SUBJ: FMS and GPS Equipment Advisory Vertical Guidance with no
Published Vertical Descent Angle

SAIB: HQ-14-25
Date: August 26, 2014

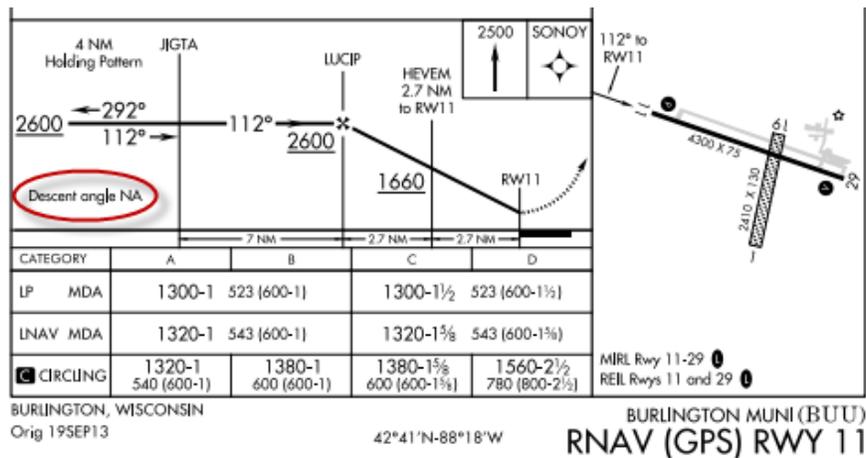
When the FAA charts these IAPs, they do not show a vertical descent angle in the profile view.

The charts currently include the following statement: “**Descent Angle NA**”. Like flying any other IAP, the pilot must see and avoid any obstacles in the visual segment during transition to landing.

The affected IAPs may create a hazard if the pilot continued to reference the advisory vertical guidance while transitioning to the visual segment of the approach. To avoid creating a possible hazard, FAA procedure designers began excluding a vertical descent angle from these IAPs and coding a “0” (zero) in the appropriate ARINC 424 database format specifications to communicate the absence of the vertical descent angle.

The FAA recommends operators and pilots carefully review departure, destination and alternate airport IAPs during pre-flight operations. During this review, operators and pilots should look for IAPs published with no vertical descent angle and charted with the statement: “**Descent Angle NA**” or “**Descent Angle NA – Obstacles**” in the profile view of the procedure. For these IAPs, the FAA recommends finding and planning to use another IAP (if available) not affected by this airworthiness concern.
