[Docket No. FAA-2011-0450; Directorate Identifier 2011-CE-010-AD; Amendment 39-16758; AD 2011-15-11]

Airworthiness Directives; Cessna Aircraft Company (Cessna) Models 337, 337A (USAF 02B), 337B, 337C, 337D, 337E, T337E, 337F, T337F, 337G, T337G, M337B, F 337E, FT337E, F 337F, FT337F, F 337G, and FT337GP Airplanes

ACTION: Final rule.

Appendix 1 to AD 2011-15-11

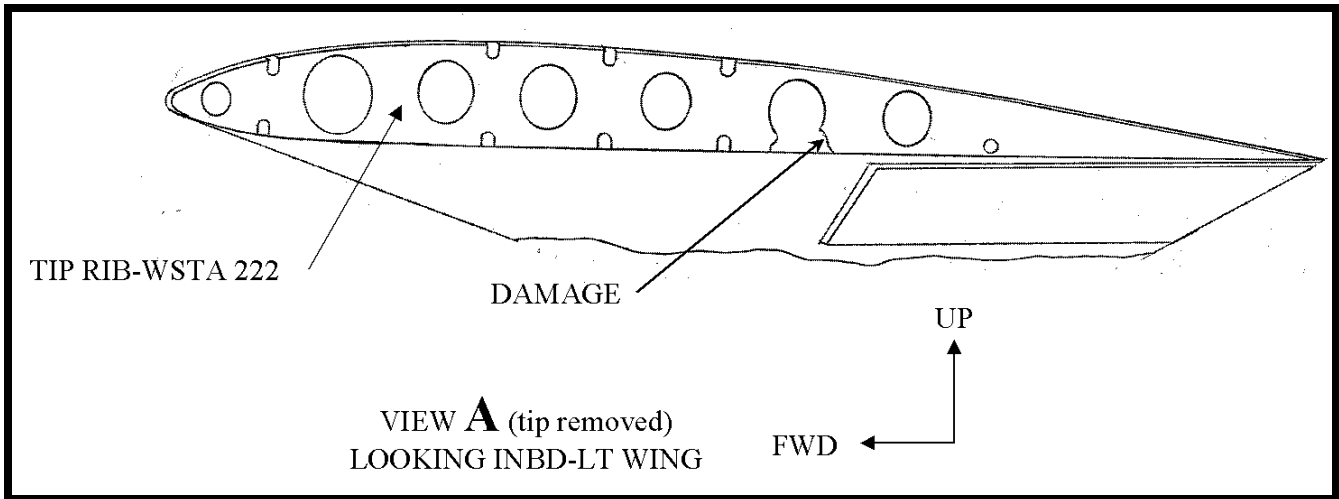
Figure 2

- (10) Inter-rivet buckling of the stringers attached to the upper surface skin, outboard of the fuel tank access covers (See View F, Figure 7).
- (11) Inspect rib at WSTA 222 for damage. Trimming of the rib may have been done to allow installation of fuel lines (See View A, Figure 2). Repair in accordance with AC 43.13-1B, Chapter 4, paragraph 4-58(g) and Figure 4-14, or by using another FAA-approved method that restores equivalent strength of the wing rib.

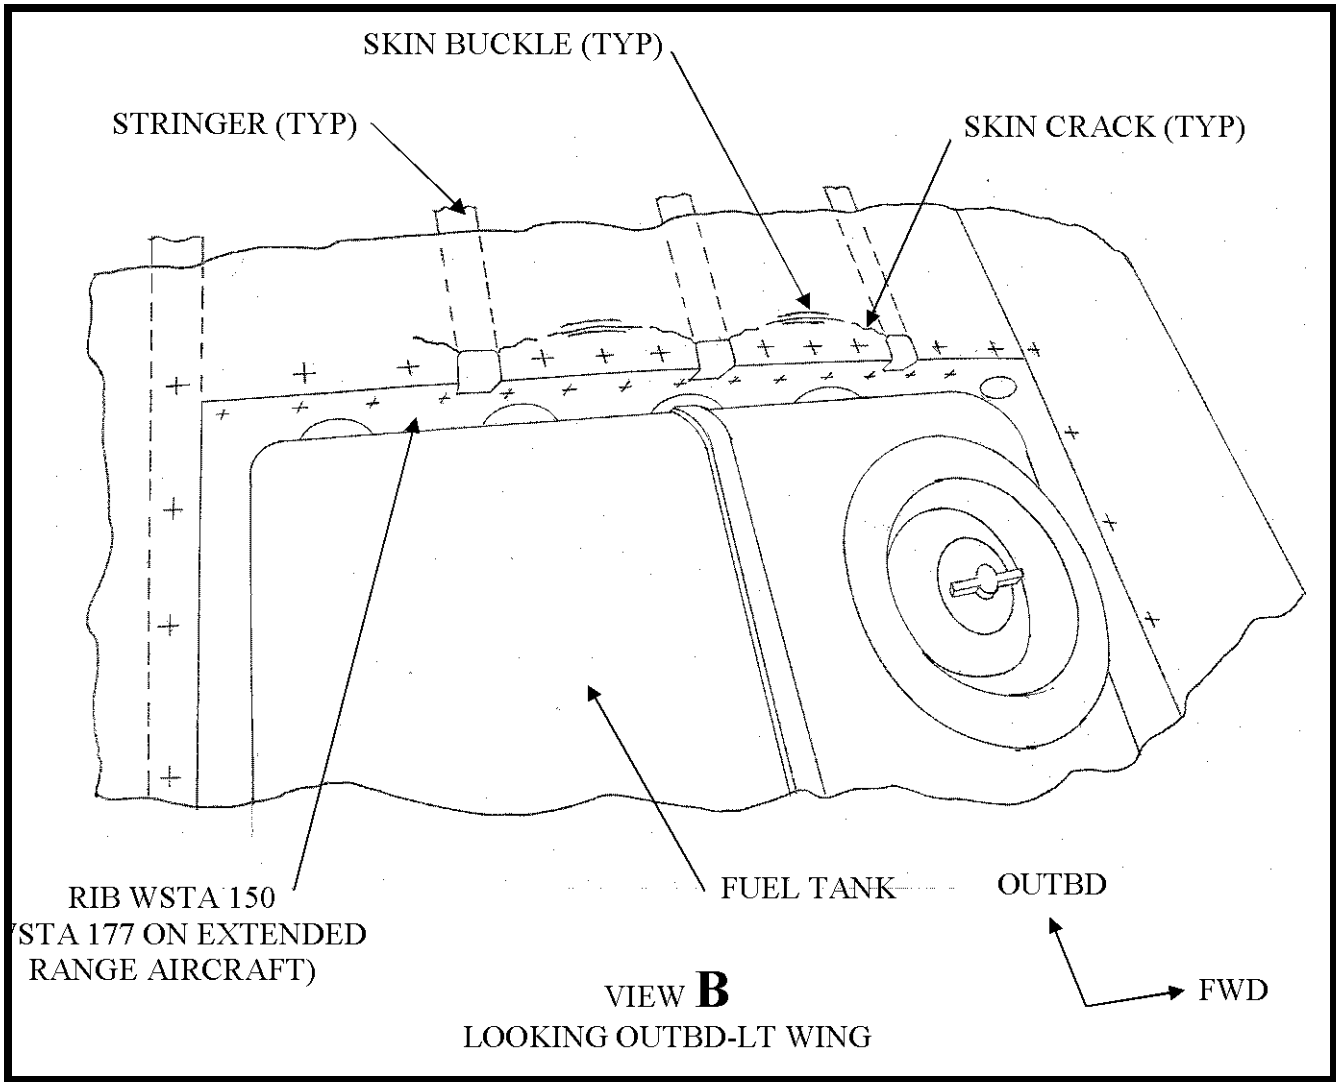
Figure 3

- (1) Wrinkles in upper wing skins, from the outboard edge on the fuel tank access covers (WSTA 150 or 177) to the WSTA 222 (See View B, Figure 3).
- (2) Wrinkles in the upper wing skins from WSTA 55 to 66, adjacent to the booms (See View E, Figure 6).

- (3) Cracking of the upper wing skins. Pay particular attention to any wrinkles, the radius between stiffeners at WSTA 150 (under fuel tank covers), and unreinforced access holes (See View B, Figure 3).

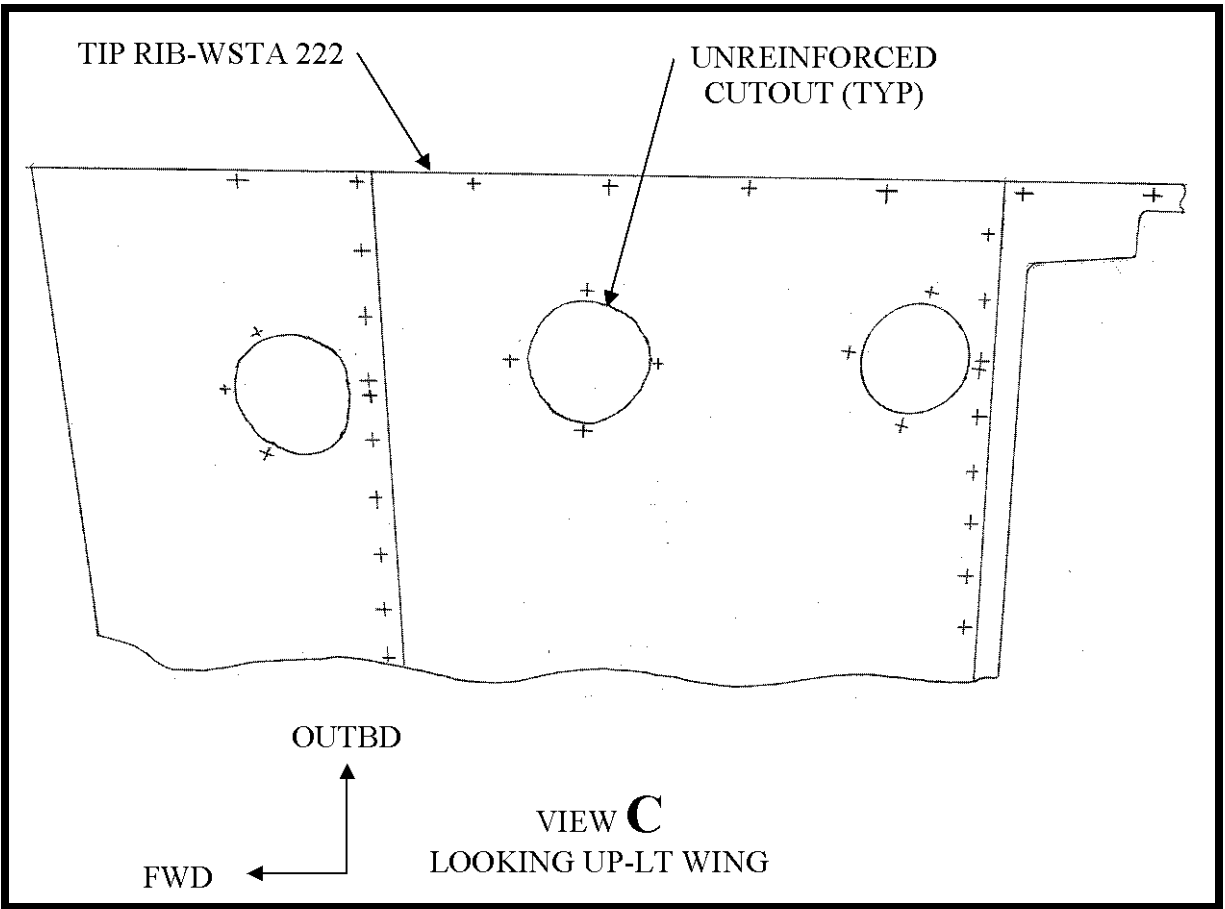
Figure 4

- (13) Inspect wing skins for unreinforced cutouts. (See View C, Figure 4).
- (14) Inspect the upper spar cap horizontal flanges for open holes (See View D, Figure 5).
