[Docket No. FAA-2011-0450; Directorate Identifier 2011-CE-010-AD; Amendment 39-16758; AD 2011-15-11]

Airworthiness Directives; Cessna Aircraft Company (Cessna) Models 337, 337A (USAF 02B), 337B, 337C, 337D, 337E, T337E, 337F, T337F, 337G, T337G, M337B, F 337E, FT337E, F 337F, FT337F, F 337G, and FT337GP Airplanes

ACTION: Final rule.

Appendix 1 to AD 2011-15-11

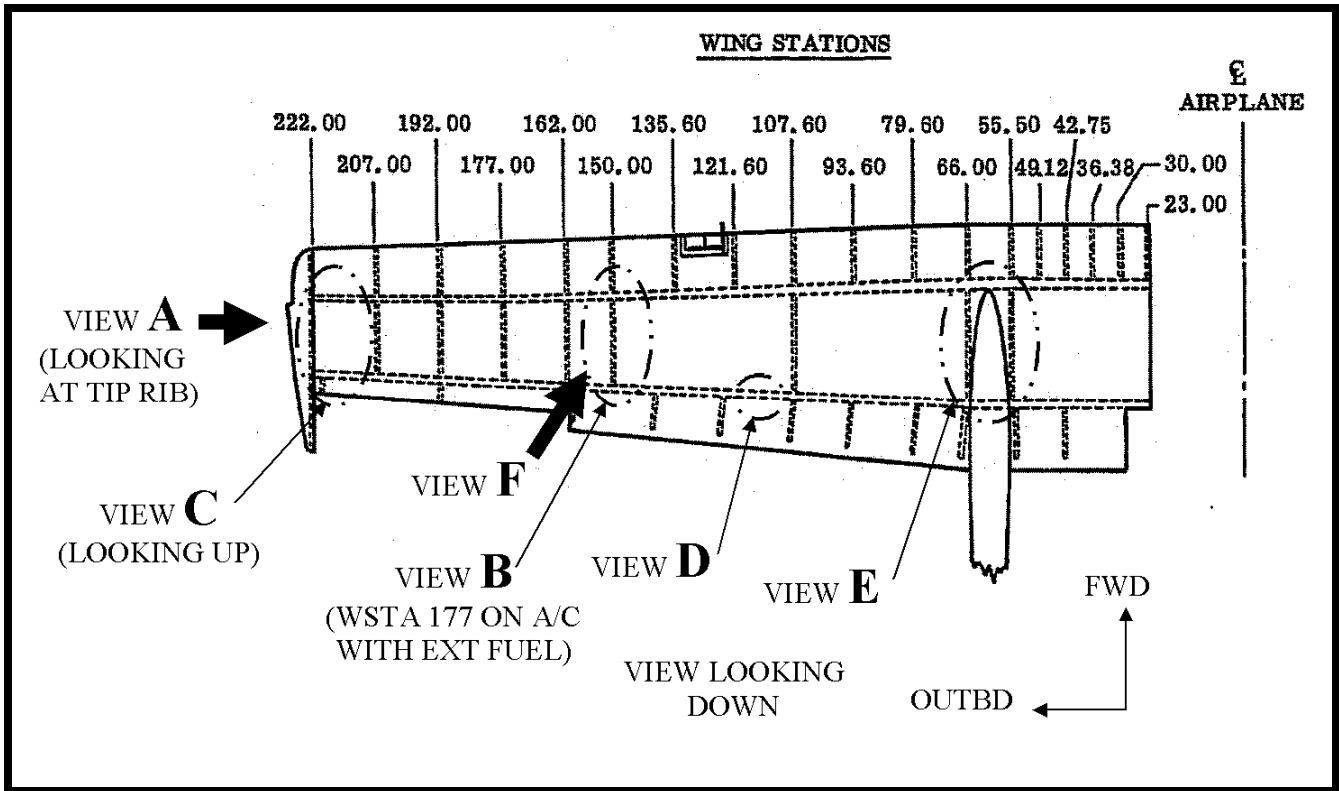
Figure 1

Perform a general and focused inspection of the wing for internal and external damage from wing station (WSTA) 23 to the wing tip. The general inspection must be performed in accordance with 14 CFR 43.15(c), using a checklist that includes at least the scope and detail of the items contained in Appendix D of 14 CFR part 43. The focused inspection must include the items listed below. Remove all wing access panels to conduct the inspections. Do these inspections following the manufacturer's service information and any other appropriate guidance, such as FAA Advisory Circular (AC) 43.13-1B Acceptable Methods, Techniques, and Practices—Aircraft Inspection and Repair. AC 43.13-1B can be found at <http://rgl.faa.gov/>.
